**BBLP & Herefordshire Council**

# **ORLETON CULVERT ASSESSMENT TECHNICAL NOTE**

**PROJECT NO. UK0029902-8520**

**OUR REF. NO. UK0029902-8520-WSP-HDG-TN-01**

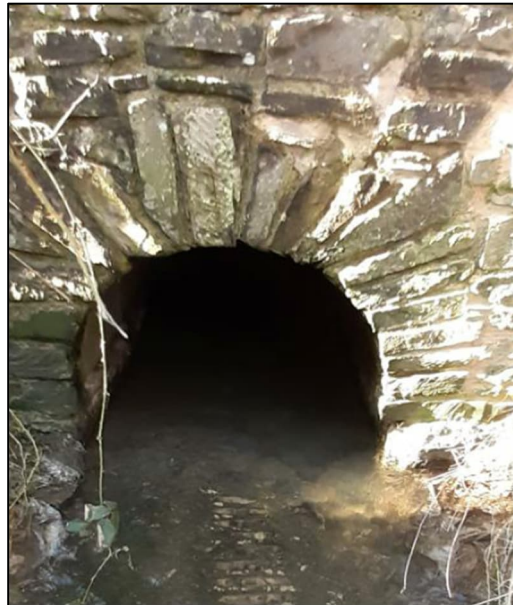
Figure -4: Downstream of B4361 Ashley Moore culvert, believed to be part of original field drainage

Reports and drone footage shared by the Parish Council, indicate that during heavy rainfall, significant flows breach the watercourse banks upstream of the 900mm culvert. Observations show a 90-degree bend in the channel just before the culvert entrance (Point A), contributing to hydraulic complexity. The March 2025 Parish Council report, *Briefing Note on the Design and Capacity of Brimfield Brook*, refers to features such as an “S-bend,” “obstructing culvert,” and “choke culvert and trap wing,” all located immediately upstream of the culvert. There are no details of these features but clearly the hydraulic conditions upstream of the B4361 are complex. Due to the absence of level or

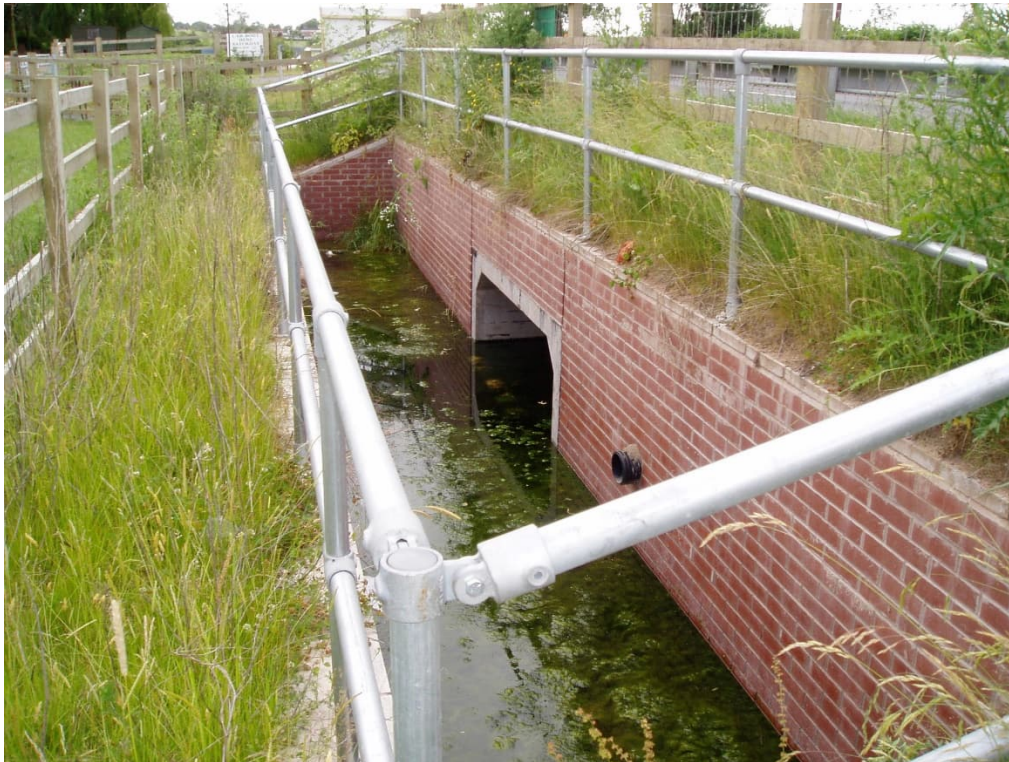
**Figure-9: Example of open chamber / channel to capture and divert water back into brook (Source: Balfour Beatty Living Places, BB1314 Nook A4103 (Roman Road) Flood Relief Culvert, 2005)**

This option involves installing a structure, large open chamber / channel, similar to that shown in Figure 9, to capture and divert flows back into the brook upstream of the B4361 to manage exceedance flows and reduce flood water flowing overland into the village via Maidenhead junction. The structure would be supported by short defence walls and integrated with revised highway drainage to redirect water away from the highway.
